New York State Department of Transportation

Yellow Flag NB22CTW001

BIN: 1065318

Location: Span 123 Girder G13 at Pier 122

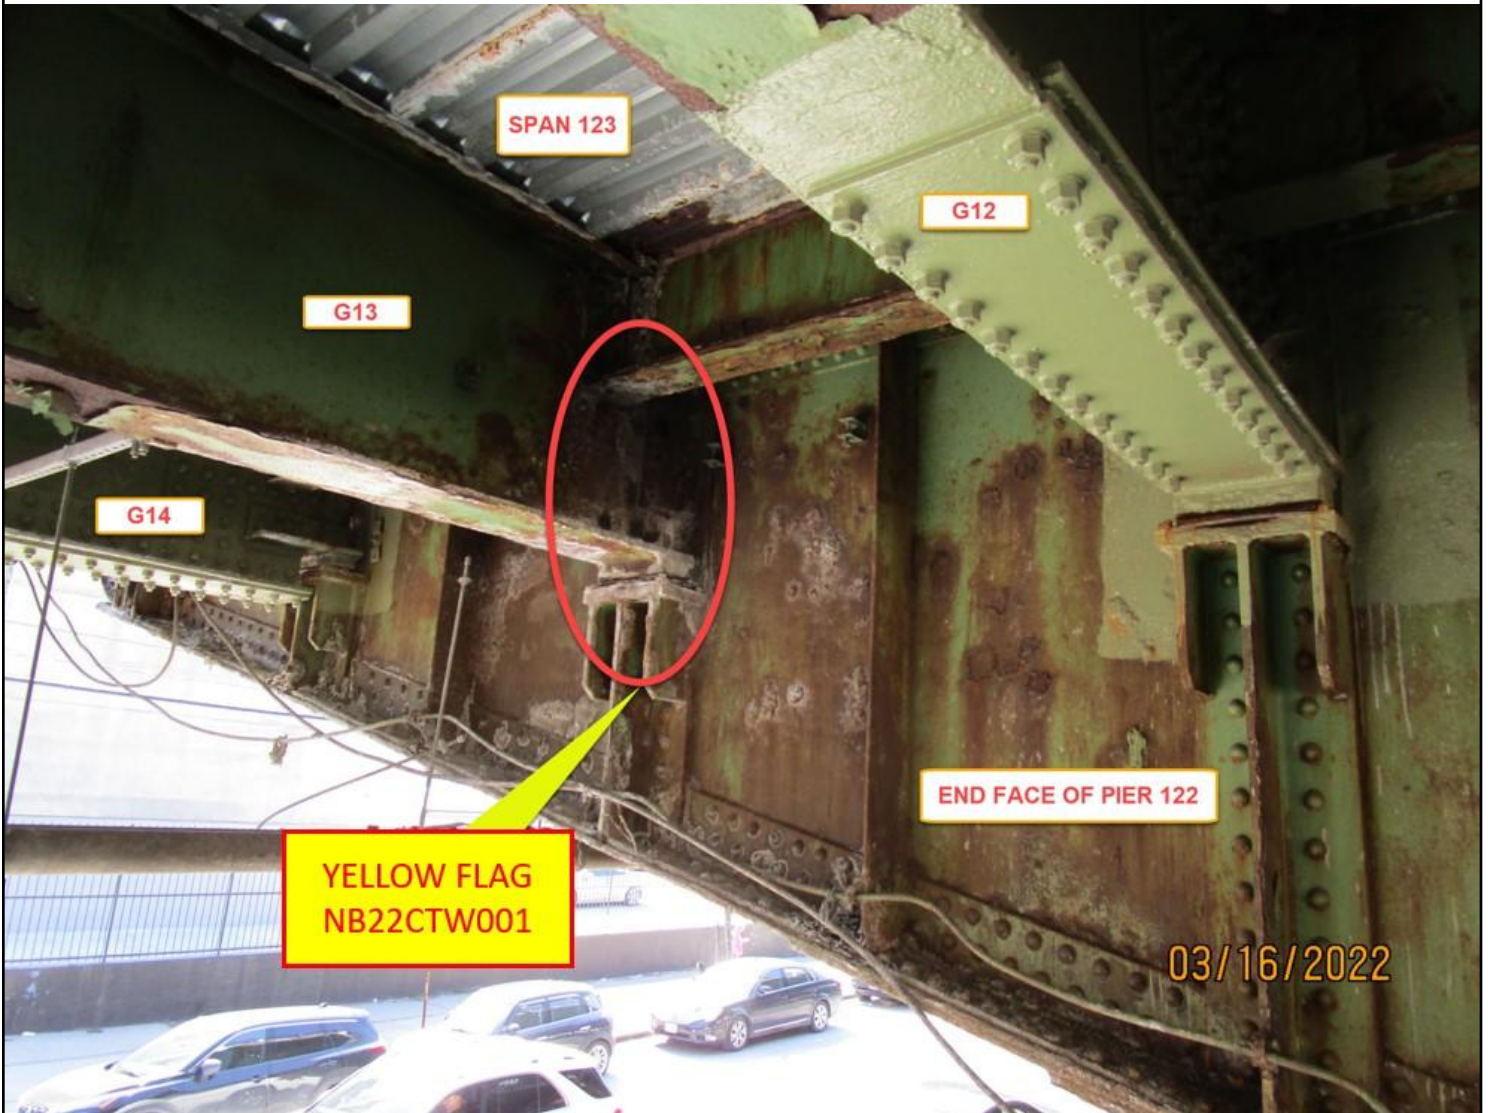
Photo Number: 1

Description: The end of Girder G13 in Span 123 at Pier 122 exhibits severe corrosion resulting in an overall web bearing area section loss of approximately 31% (previously 35%) and an overall shear web area section loss of approximately 44% (previously 42%) with an average overall localized section loss of approximately 41% (no change) for 5"L x 6"H area directly above the bearing below the guide angle (Photo 2). The end of the girder web exhibits two corrosion holes; a 2" diameter hole adjacent to the middle pre-drilled guide angle hole and a 3"L x 1"W hole adjacent to the top pre-drilled guide angle hole (Photos 3 and 4). Also, the lower web of the girder adjacent to the web bearing area exhibits an average section loss up to 30% for 24"L x 3"H above the bottom flange. There is no significant change in the condition since the previous inspection. (Refer to sketch for more details).

Attachment Description: General view of the flagged condition at Girder G13 in Span 123 at Pier 122. Looking Begin and Right.

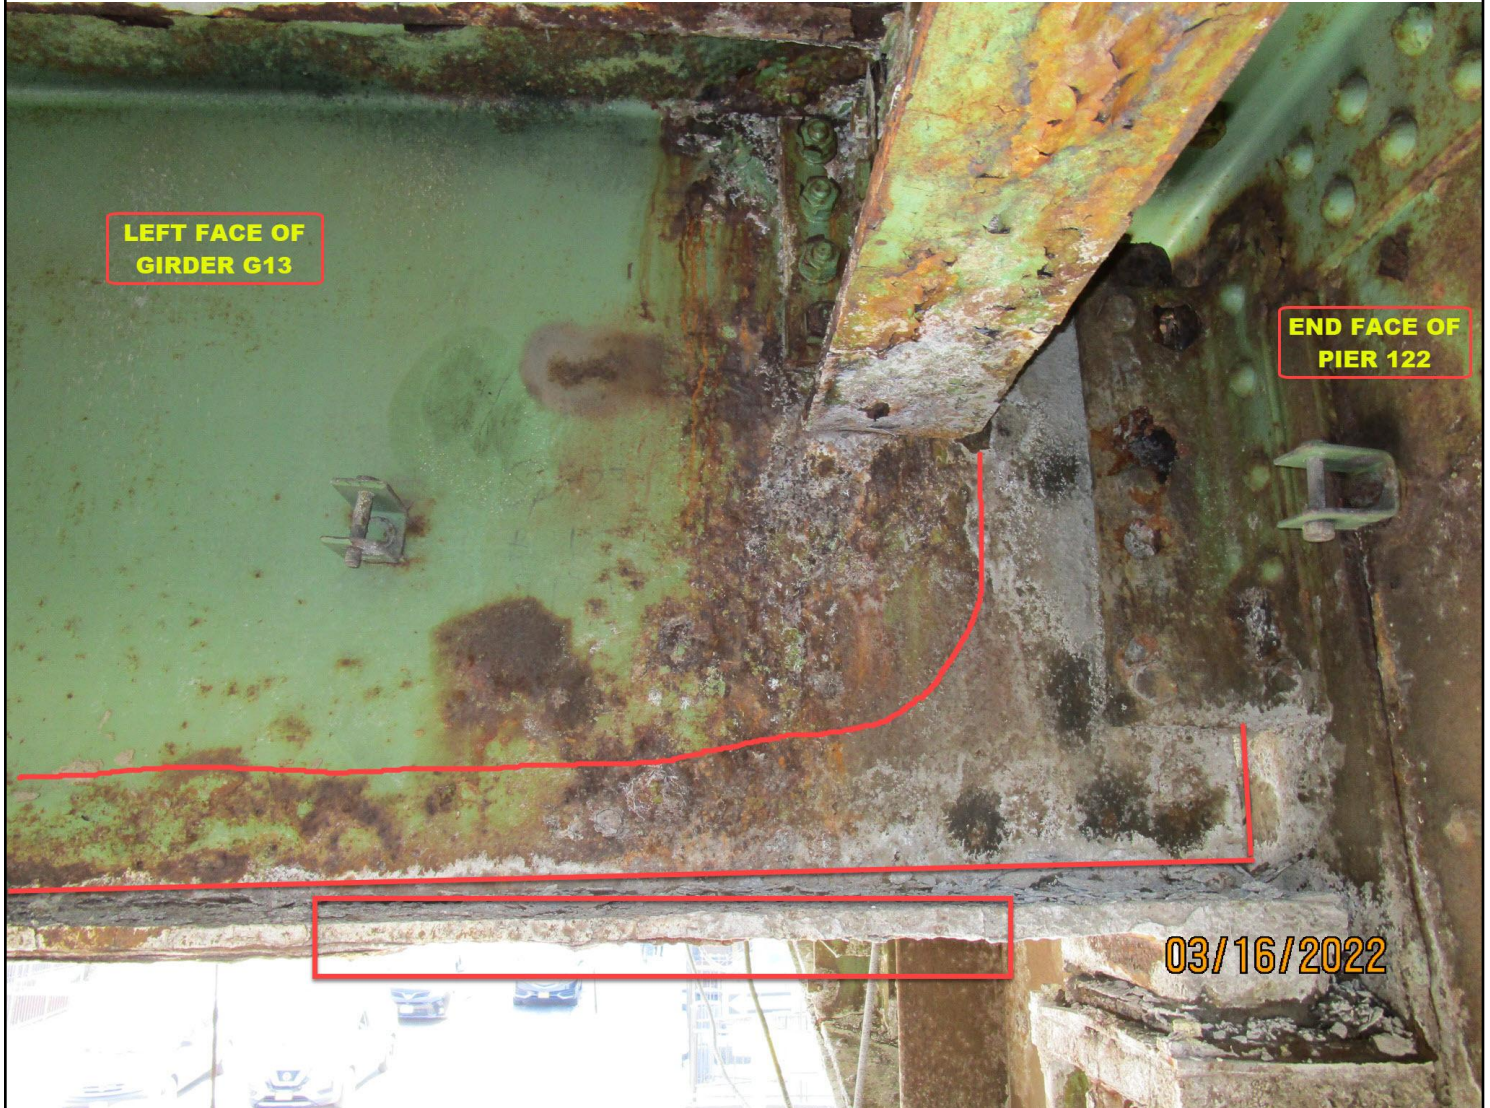
Photo Number: 2

Attachment Description: The left face of Girder G13 in Span 123 at Pier 122. The end of the girder exhibits severe section loss at the lower web above the bottom flange and web adjacent to the guide angle. Looking Right.

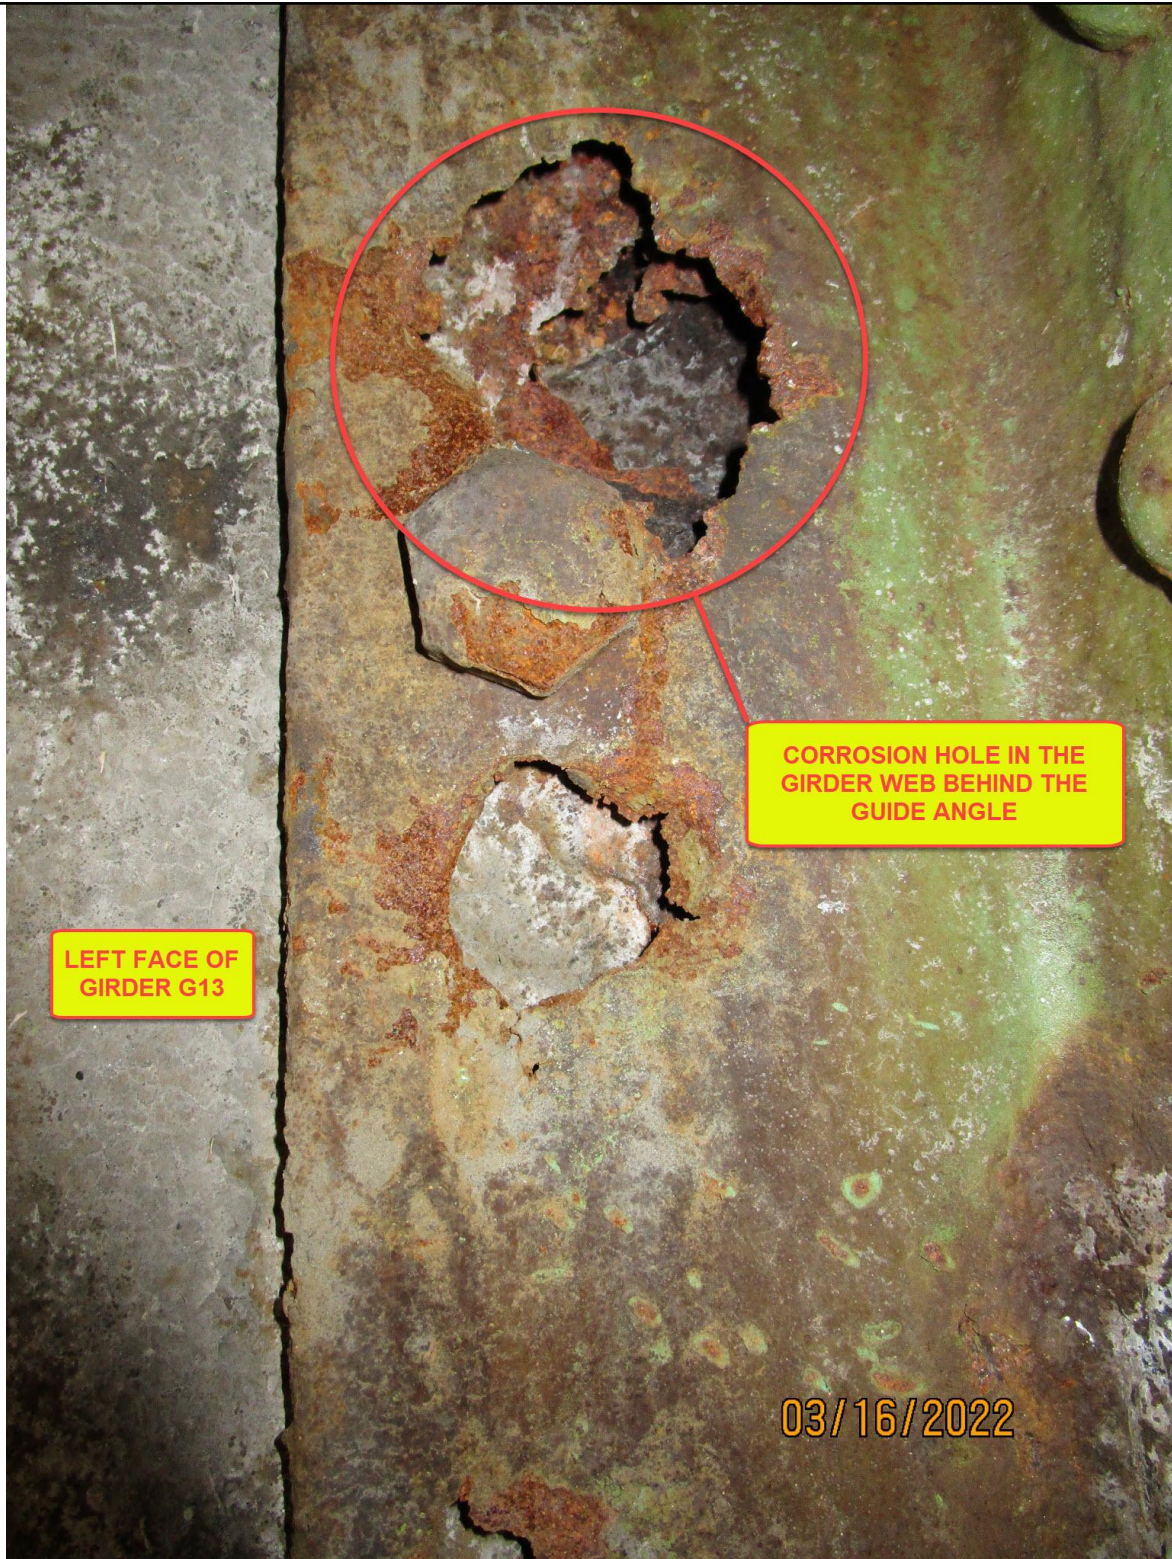
Photo Number: 3

Attachment Description: The left face of Girder G13 in Span 123 at Pier 122. The end of the girder web exhibits a corrosion hole behind the guide angle adjacent to the middle pre-drilled hole. Looking Right.

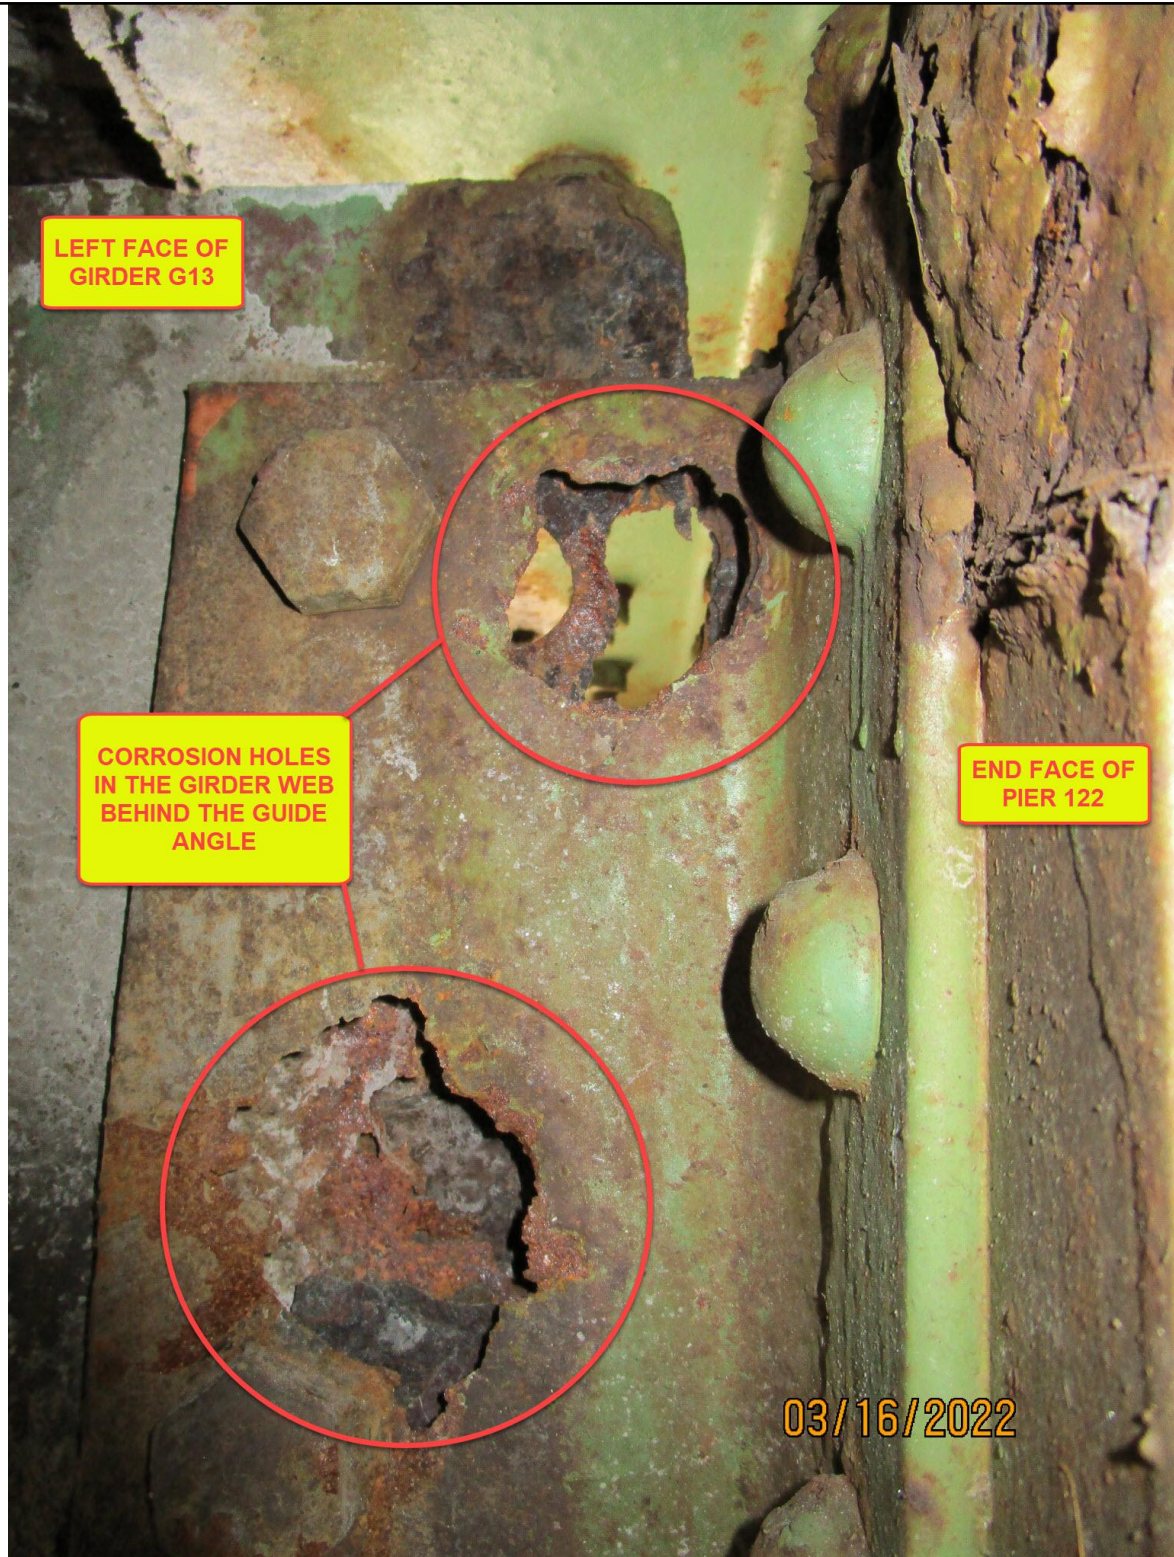
Photo Number: 4

3. The left guide angle exhibits four corrosion holes for 1" diameter, two 2" diameter holes, and 3" diameter. The right guide angle exhibits one corrosion hole for 4"L x 2"W at the top of the angle. The condition is the same as reported in the last inspection.

Attachment Description: The left face of Girder G13 in Span 123 at Pier 122. The end of the girder web exhibits corrosion holes behind the guide angle adjacent to the middle and top pre-drilled holes. Looking Right.

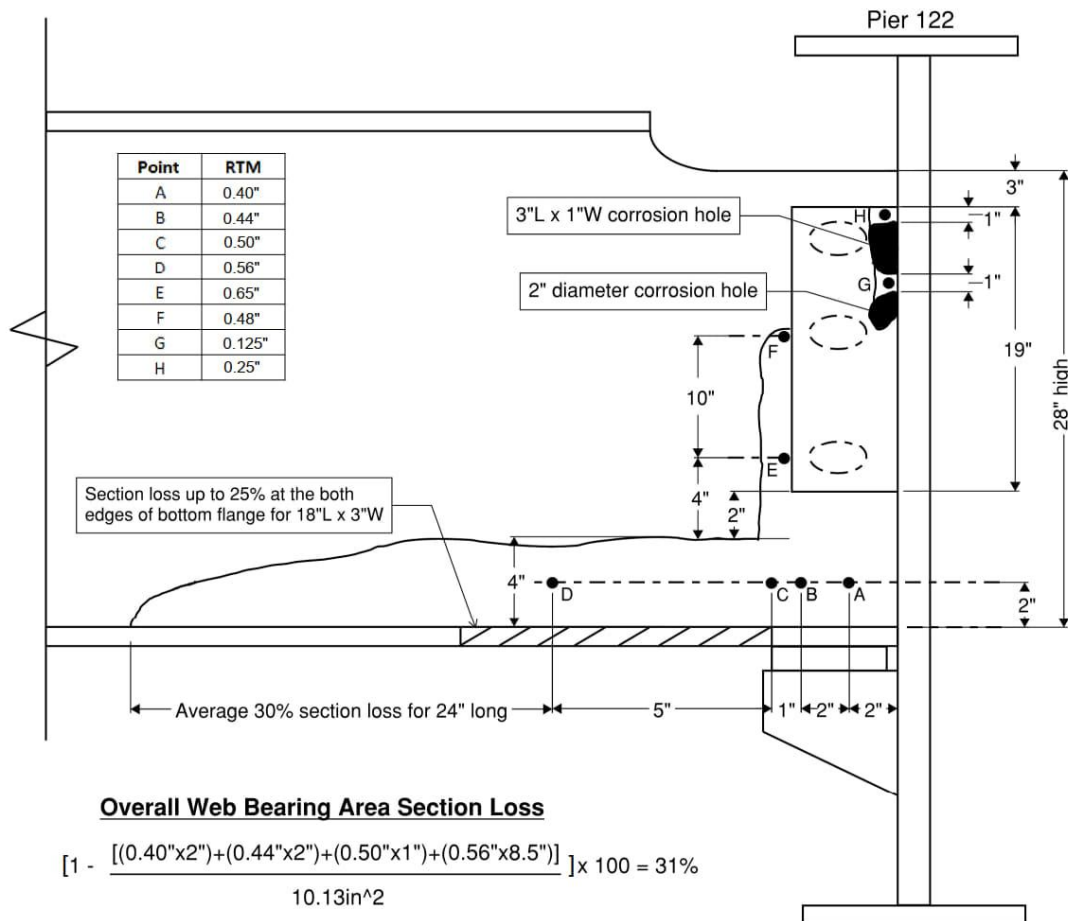
Left Face of Girder G13 Sketch in Span 123 at Pier 122

**Overall Shear Web Area Section Loss**

$$[1 - \frac{[(0.40" \times 4") + (0.65" \times 4") + (0.48" \times 10") + (2" \times 0") + (0.125" \times 1") + (3" \times 0") + (0.25" \times 1") + (0.75" \times 3")]}{21 \text{ in}^2}] \times 100 = 44\%$$

- As-built web thickness = 0.75"
- Length of bearing area = 18 x web thickness = 18 x 0.75" = 13.50"
- Overall bearing area = 13.50 x 0.75" = 10.13 in²
- As-built shearing web area = 28" x 0.75" = 21 in²
- Adjacent Girders G12 and G14 have previously installed steel reinforcement plates and angles at the end of the girder.
- Left guide angle at Girder G13 exhibits four corrosion holes for 1" diameter, two 2" diameter holes, and 3" diameter. These defects are not shown in the sketch for clarity purposes to display girder defects.
